Volvo Steering Shaft Recall Fact Sheet

Models: 2016 and 2017 Volvo VNL, VNM, and VNX Models with a 2-piece steering shaft.

Build Dates: May 11, 2015 through March 8, 2016.

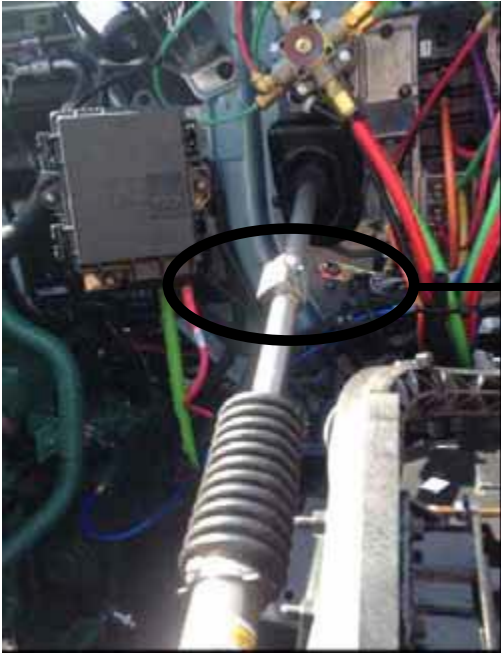
Figure 1

Type of Steering Shaft: 2-piece, as shown as below. The joint in question is circled in the picture on the left below (Figure 1), with a close-up view shown in the picture on the right (Figure 2).

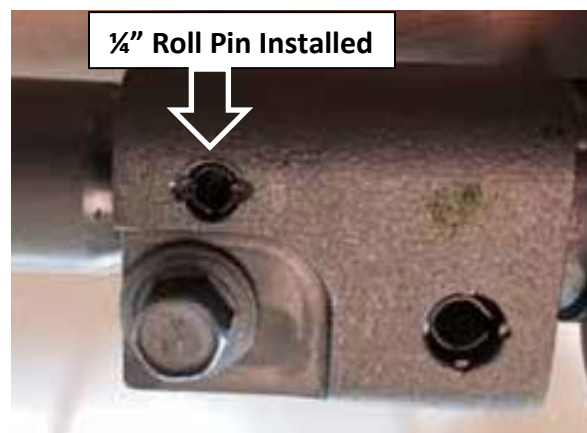
Figure 3

Interim Fix: Volvo has identified an interim fix which involves drilling an additional hole, and inserting a ¼ inch roll pin. If this solution is applied, the truck is safe to operate and is **NOT** to be placed out-of-service. A picture of the interim solution is shown below (Figure 3):
